## Roman building practice in Aphrodisias

### Gerhard Paul

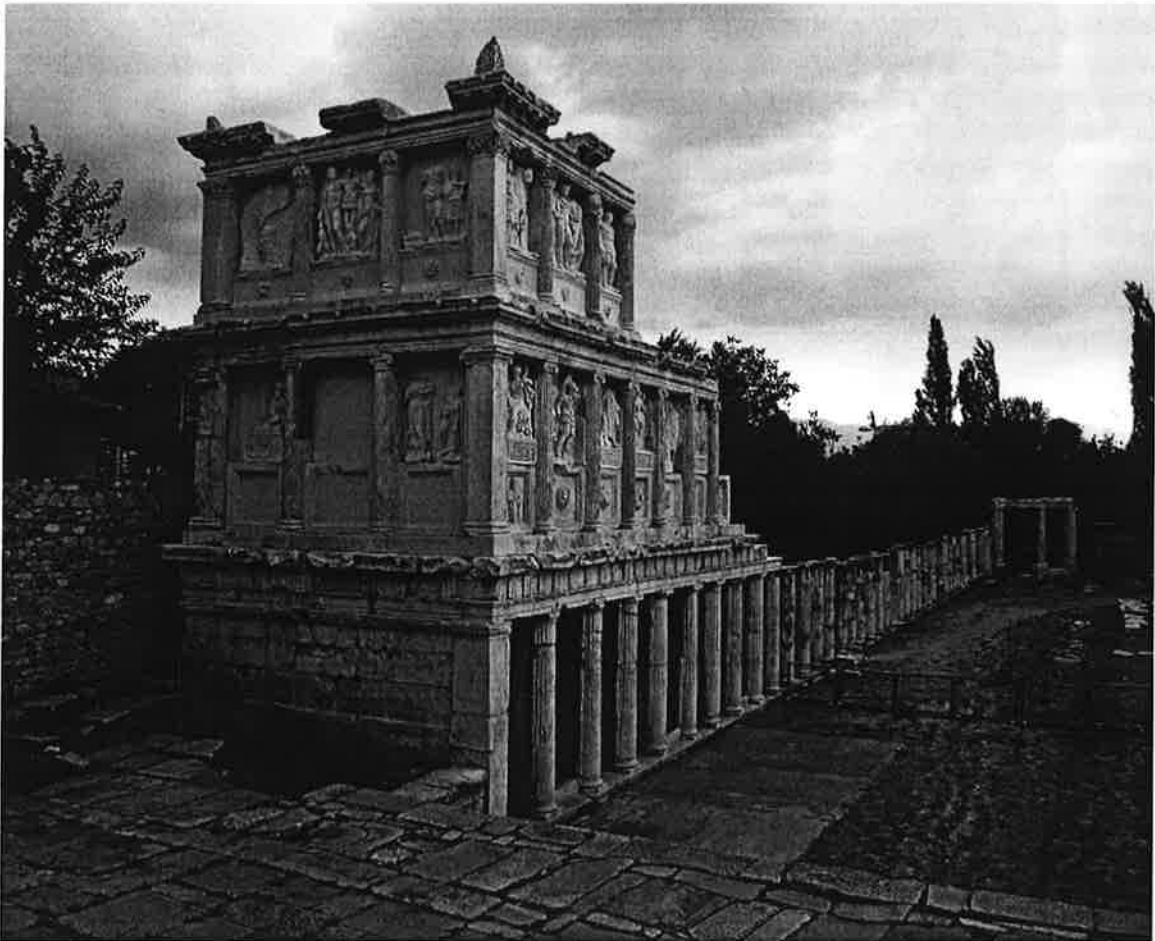
Fig. 17.1. Sebasteion South building. Anastylosis (2014), looking southwest.

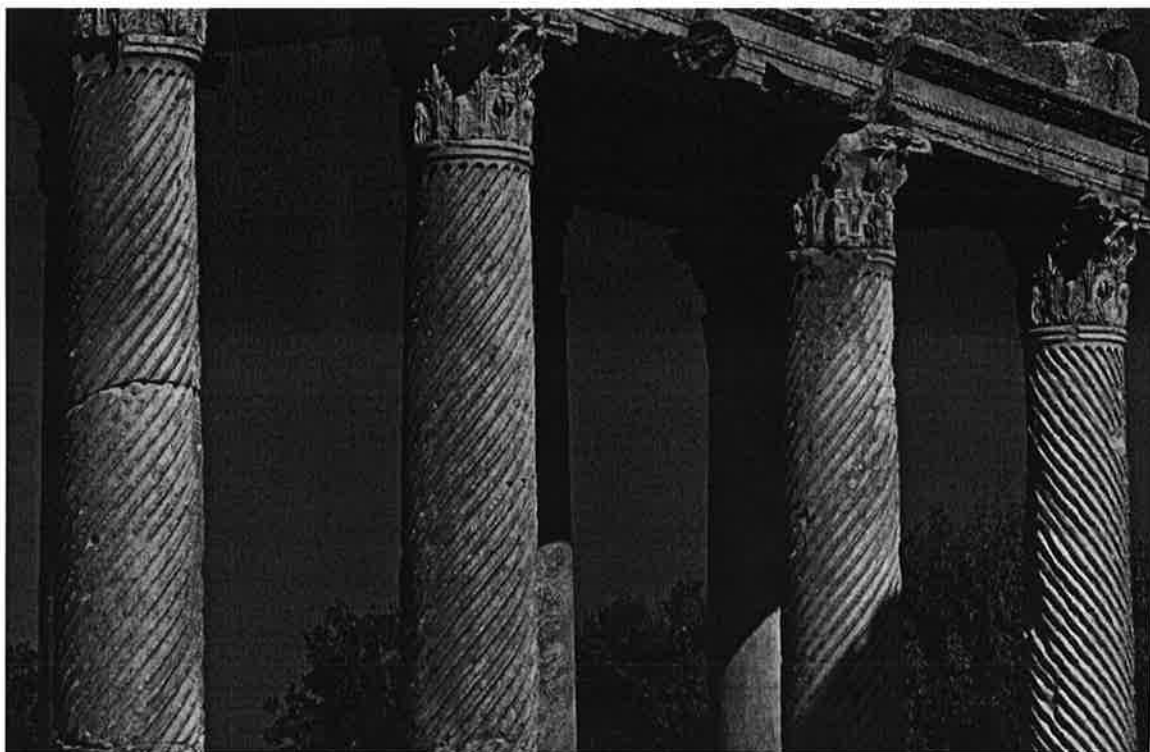
Fig. 17.4. Tetrapylon. Column spiral fluting in the wrong direction in second row of columns from the west.

All these measures facilitated the choice and selection of raw materials, lent flexibility to the construction logistics, and lowered the overall costs. Buildings that required large elements such as monolithic columns and architraves with wide spans were expensive. When the proper raw material was not available, adjustments to the original plan were made during construction to increase work efficiency and lower costs. Irregularities and mistakes (whether from human error, financial issues, or pressure of time) might occur during construction and might not be corrected deliberately. A spiral-fluted column from the Tetrapylon is a good example (fig. 17.4): the fluting of one

of the columns in the second row of the E part does not fit into the established pattern of clockwise and counter-clockwise spiral-fluted columns, but, despite this mistake, the column was built in with no attempt to conceal the problem.<sup>7</sup>

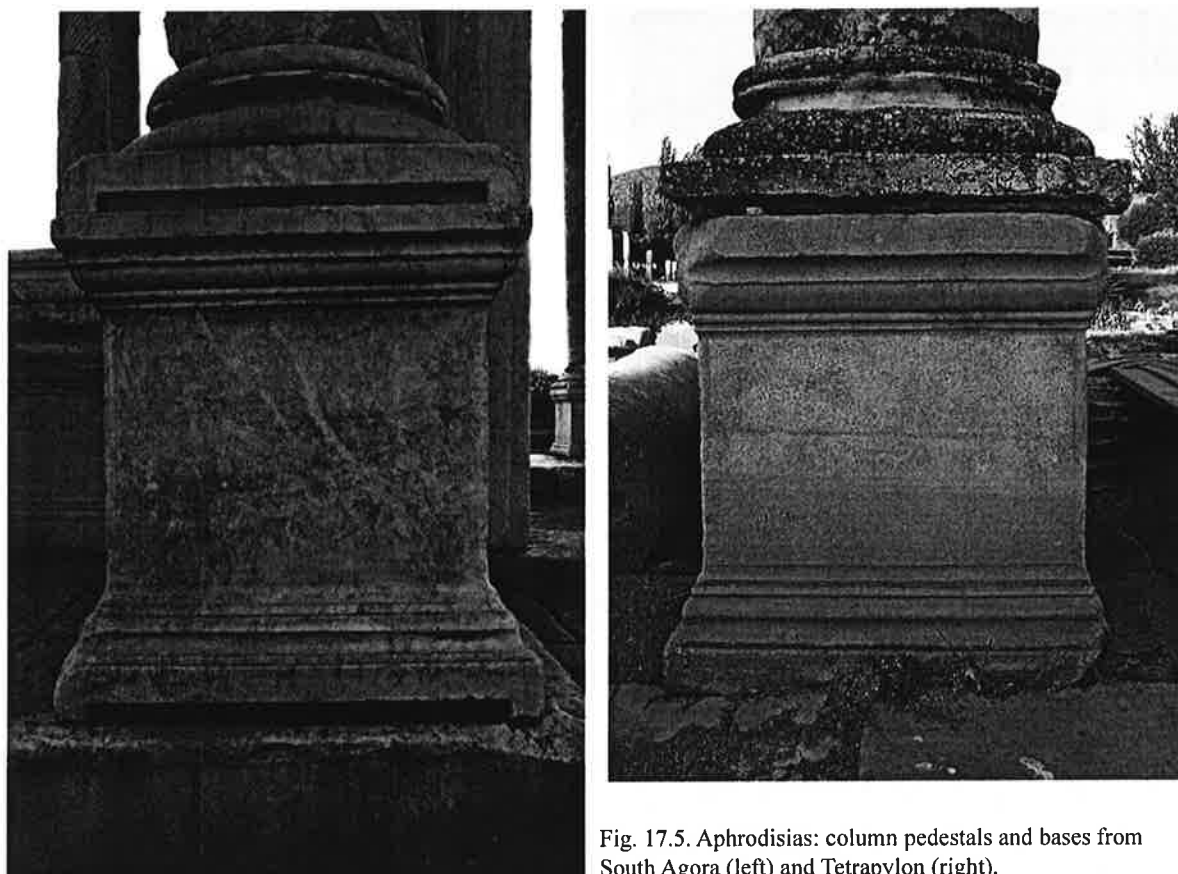
Fig. 17.5. Aphrodisias: column pedestals and bases from South Agora (left) and Tetrapylon (right).

The Tetrapylon offers a good example of the prefabrication process while revealing the standardization of elements. The 16 columns vary in height by up to 15 cm. This can be partly explained by the gradient of the street on which the Tetrapylon stands. As it slopes gradually from north to south, the stylobate of the N and S parts have different levels, with the result that the columns needed capitals of different heights, yet two capitals of an identical prefabricated type were used. To compensate for the difference in height, one had its lower part cut down by *c.*5 cm, regardless of its decoration.<sup>11</sup> Note that the column pedestals and bases are identical in size and profile with pieces that were used in the “South Agora” during the 2nd c. A.D. (fig. 17.5).<sup>12</sup>

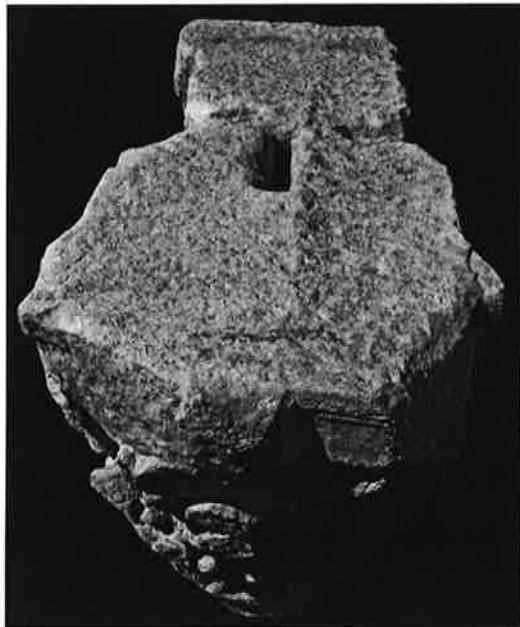
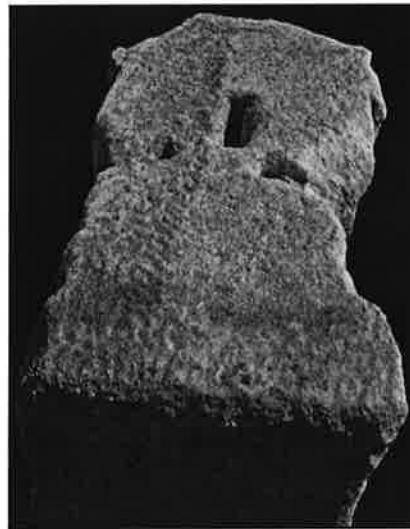
Fig. 17.10. Sebasteion. South building. Corinthian capital, top view front and back.

Modifications were sometimes made on the lower part of a block in order to line up continuous decoration. For example, one side of the top of a Corinthian capital was cut down to have the architrave sitting at the correct height, so that its decoration (profiles, fasciae) lined up with that of the neighbouring block (fig. 17.10). Various 'unfinished' examples indicate that decoration close to joints between blocks was normally finished once the neighbouring pieces were put in place (figs. 17.11-17.12). This can be seen in all kinds of continuous mouldings, such as bead-and-reel and egg-and-dart, and in the fluting of columns. This allowed flexibility and facilitated any necessary corrections between two adjacent pieces. A notable mistake can be seen on an Ionic column and its capital in the first room of the South Building in the Sebasteion (fig. 17.13). The capital broke while the fluting in the upper part of the column was being finished. The capital was repaired with a clamp, but the right part of the column and the capital were deliberately left unfinished in order to avoid possible further damage to the piece. The fluting of columns was often left unfinished. An example can be found in the Corinthian columns of Rooms 1 and 2 in the South Building where the lower parts of the columns and their bases were put in place and left partly unfinished.

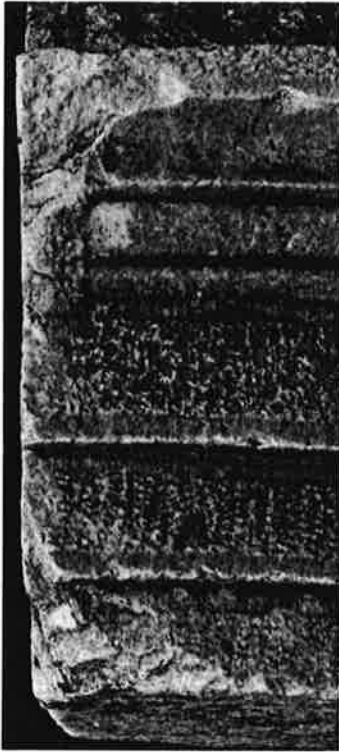
Fig. 17.12 (above). Sebasteion. Propylon, podium crown moulding, with unfinish at joint.

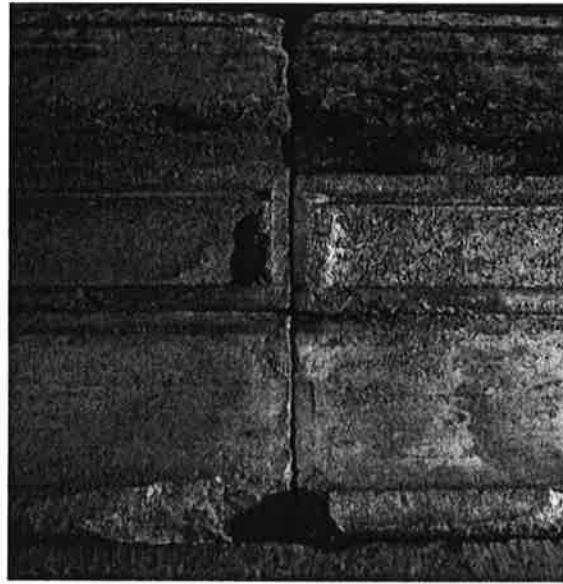
Fig. 17.11. Agora Gate. Unfinished moulding at joint.

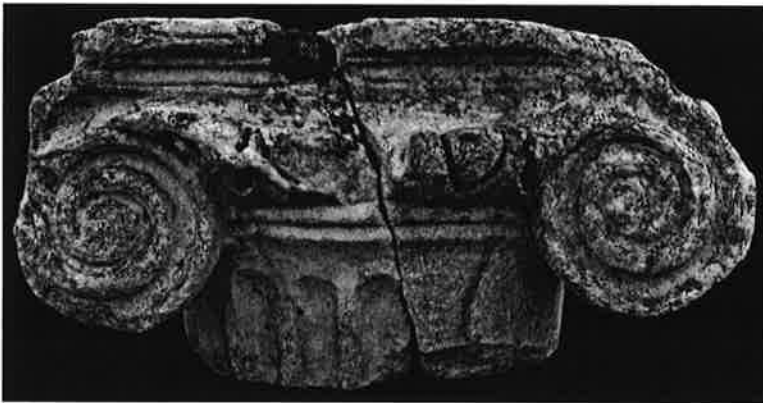
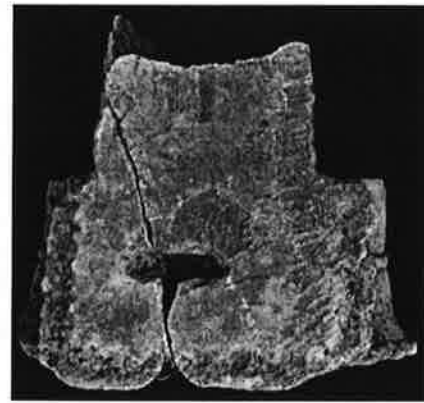
Fig. 17.13. Sebasteion. South building, Ionic capital, front and back.

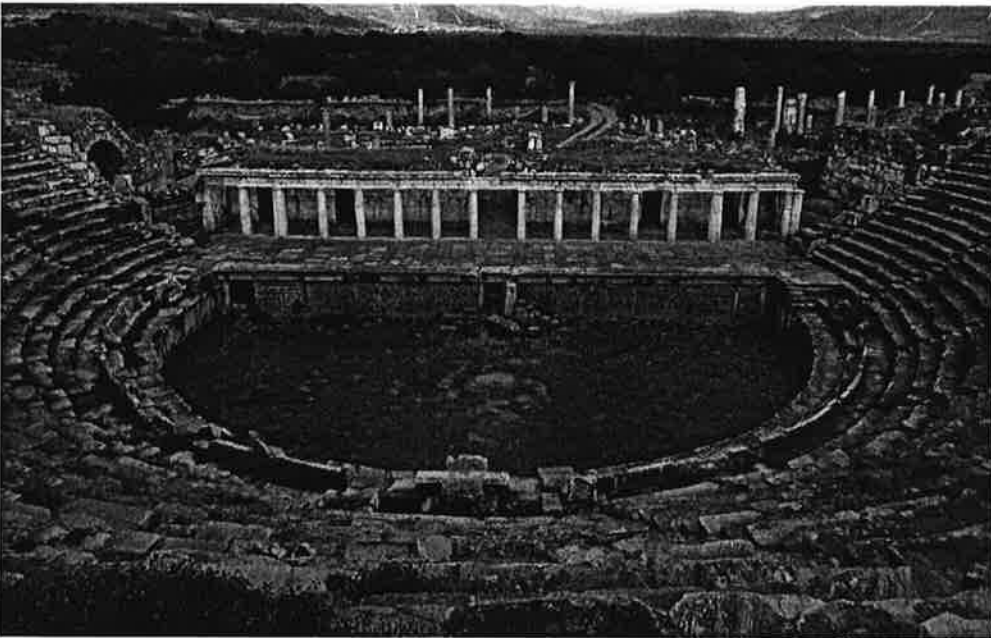
Fig. 17.16. Theatre *logeion*, after anastylosis (2013).

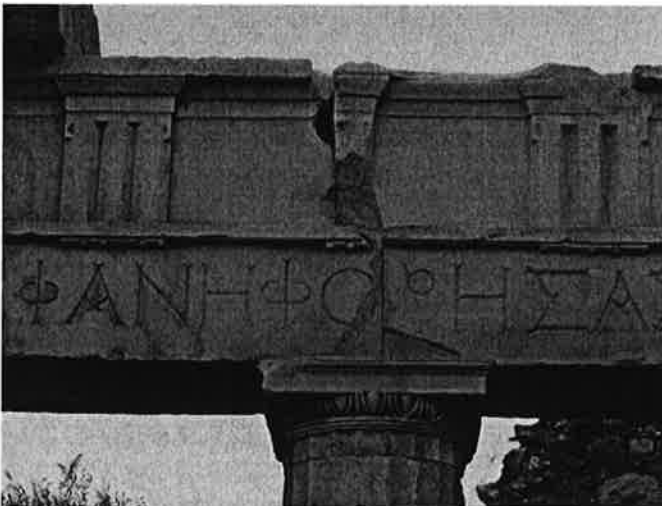
Fig. 17.17. Theatre, *logeion*. Repair disrupting triglyph.

an existing block was cut down to the necessary length and fitted to the neighbouring block, but with an ill-fitting, partly-cut triglyph.
